# **General Aviation Airworthiness Alerts**

**AC No. 43-16**

**ALERT NO. 224  
MARCH 1997**

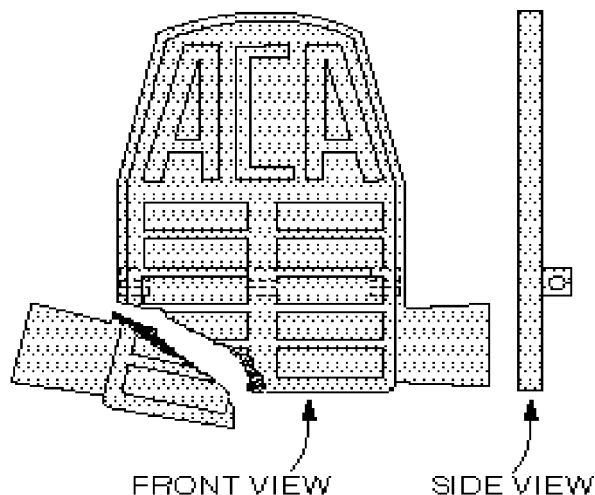
The owner of this aircraft reported a third rudder pedal failure in 298 hours of operation.

All of the rudder pedals (P/N 1537-1) failed at the lower left corner and were installed in the left forward position. The first failure occurred within 147 hours of operation, the second within 86 hours of operation, and the third within 65 hours of operation. This rudder pedal has three mounting pads on the back of the pedal through which the hinge pin passes. (Refer to the following illustration.)

The submitter did not offer a conclusion as to the cause of this defect and the short life of the pedals.

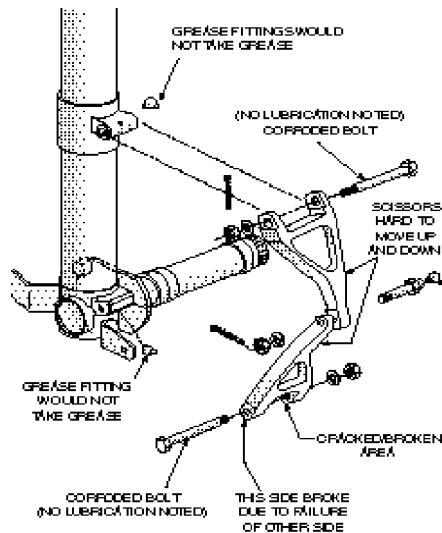
An inspection revealed the left main landing gear scissors (P/N TB1041033000) had broken, allowing the wheel to turn sideways. The scissors broke on the lower half, adjacent to the strut attachment point. It appeared the fracture was the result of a pre-existing crack on the outboard side of the scissors fitting. The attachment pins (which hold the scissors) were severely corroded, and there was no evidence

of lubrication. Also, the grease fitting would not accept grease, and the scissors were extremely difficult to move. The submitter speculated this caused excessive stress on the scissors assembly, and led to this failure. (Refer to the following illustration.)

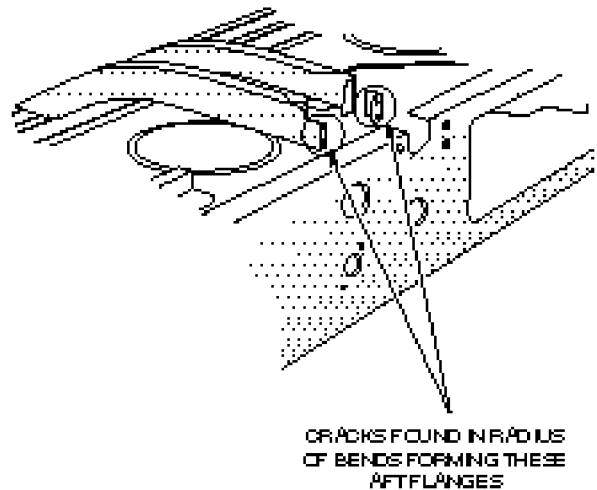
Both the left and right flight control yoke assemblies were found cracked during a scheduled inspection. Three separate reports on like aircraft were received stating the same defect.

The cracks were located in the bend radii of the aft flange support halves (P/N's TB10 23012100 and TB10 2301201). (Refer to the following illustration.) One side of the flange was severed, and the other side was very close to failure. These cracks are impossible to see without lifting the pilot's instrument panel. It was the submitter's opinion that this damage was caused by the transfer of wind gust loads from the control lock assembly.

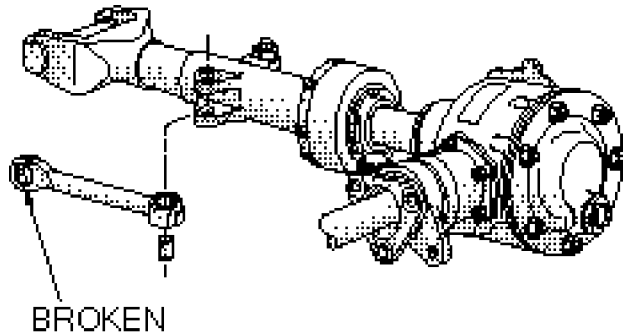
One of the tail rotor pitch control rods (P/N 350A33-2145-00 or -01) was found broken during an investigation. The spherical bearing installed in that control rod displayed excessive wear. (Refer to the following illustration.) There are two part number control rods eligible for installation on this aircraft, and the exact part number installed was not known. At the time of this report, it was not known if the bearing or the control

rod failed first; however, it was speculated that the worn bearing set up an abnormal vibration which caused the tail rotor pitch control rod to fail.

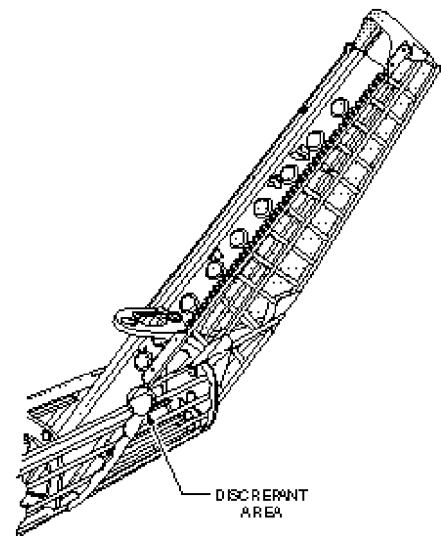
As the result of a noninjury aircraft accident, the FAA and the NTSB have discovered a structural deficiency in the vertical fin of the helicopter models previously mentioned. This deficiency may lead to structural failure and/or separation of the vertical fin. Metallurgical examinations have revealed the vertical fin forward spar may be subject to failure through the Number 1 rivet hole. The failures appear to result from high cycle fatigue which is consistent with short cycle

The helicopter involved in this accident had been fitted with the latest design vertical fin spar, which was installed during manufacture. While definitive numbers cannot be determined, initial calculations suggest the aluminum vertical fin spar has an ultimate life of approximately 200,000 heavy lift, maximum power cycles. Any damage to rivet holes during tailboom repair, or evidence of working rivets has been demonstrated to further reduce the ultimate life of the spar. Heavy external lift at gross weight or above, "snatching" loads off the ground, applying full right pedal to unload the tail rotor to achieve additional main rotor lift, and jerking loads airborne, all contribute to shorter ultimate life of the antitorque structure.

Airworthiness Directive (AD) 71-21-02 previously addressed this subject on Models 205A and 205A-1 and further AD action is contemplated. The FAA recommends that operators pay special attention to the vertical fin spar cap and inspect the discrepant area before the first flight of each day until more effective corrective action is available. (Refer to the following illustration.)
